## Contractor Light Vehicle Accident - Multiple Casualties.

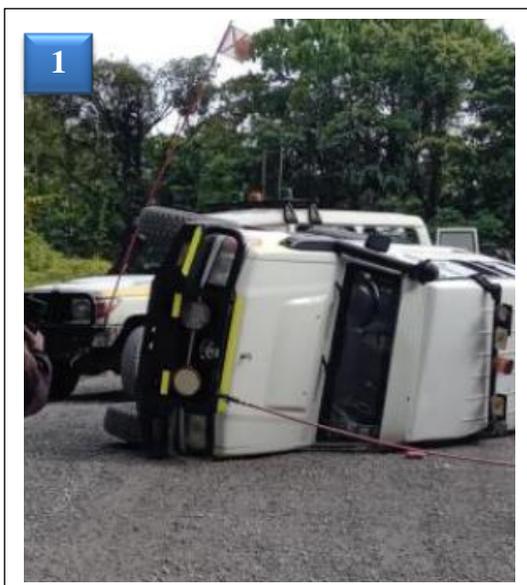
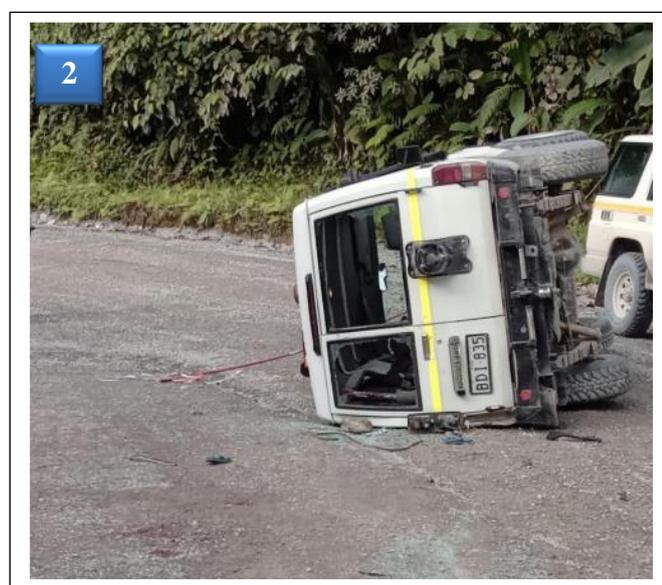
A high potential vehicle incident occurred on a mine easement road. The driver of the light vehicle (10-Seater Troop Carrier) lost control and the vehicle whilst travelling downhill turned over and came to rest on its side. There were nine (9) passengers on board; four (4) sustained injuries including the off sider who were on the impact side of the vehicle whilst the driver and the other four (4) were not injured.

- Inadequate fatigue management.
- Not driving within speed limits and to road condition(s).
- Lack of proper maintenance system for light vehicle(s).
- Incompetency of driver.
- Inadequate contractor management and supervision.
- Inadequate enforcement of light vehicle policies.
