Haul Truck Accident

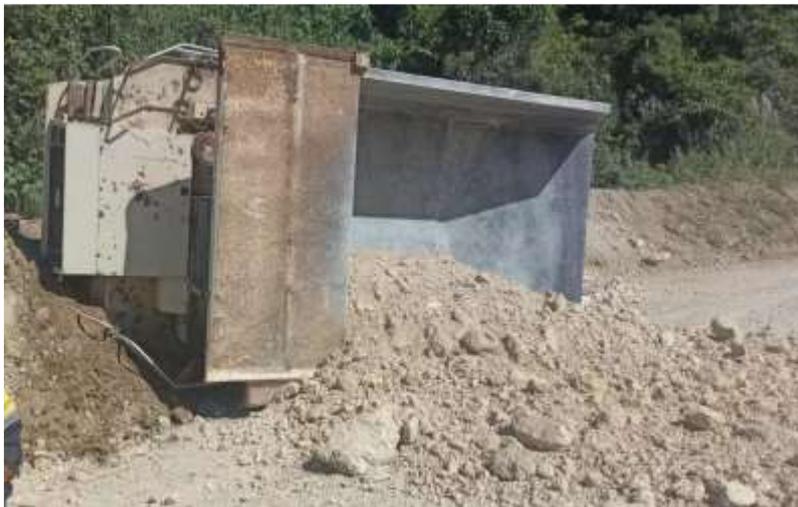
A loaded Terex haul truck was travelling downhill along an access road when the driver lost control of the truck whilst under descent and came into contact with the safety berm before capsizing.

Photos of accident site and vehicle involved

Learnings: We have repeat of such incidents across our mines where contributing factors include: operator error, incorrect gear selection, poor road conditions, operator fatigue and poor mechanical condition of the truck. To avoid repeat of such incidents, the following observations are to be reinforced.

- Incompetency of truck operator – ongoing awareness and refresher training
- Unsafe road condition – ongoing road maintenance
- Unsafe haul truck mechanical condition – improve maintenance on aging fleets
- Inadequate operator behavior monitoring & supervision – install operating monitoring systems to monitor operator behavior.
